**VILLAGE OF SUGAR GROVE  
BOARD REPORT**

**TO:** VILLAGE PRESIDENT & BOARD OF TRUSTEES  
**FROM:** ANTHONY SPECIALE, DIRECTOR OF PUBLIC WORKS  
BRAD MERKEL, PUBLIC UTILITIES SUPERVISOR  
**SUBJECT:** RESOLUTION: PHASE II OF THE WELL #10 REHAB PROJECT  
**AGENDA:** MARCH 3, 2020 REGULAR BOARD MEETING  
**DATE:** FEBRUARY 20, 2020

VILLAGE OF SUGAR GROVE  
 WELL #10 PUMP INSPECTION REPORT

JOB NAME	SUGAR GROVE	WELL	10	DATE	02/10/2020
JOB NO.	992598	INSPECTED BY	J. KOPP, J. POPPEN, M. POPPEN, B. BALLUFF		
		BOWL ASSEMBLY	Byron Jackson 13 stage 12EMM		
		COLUMN ASSEMBLY	10" T&C Line Pipe		
		MOTOR	Byron Jackson 300 HP, 460V, 14", Type H

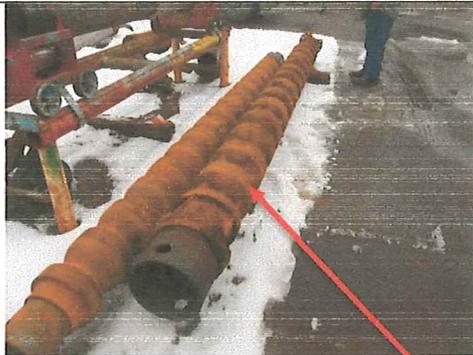
Byron Jackson 13 stage 12EMM bowl assembly

Replace bowl assembly.

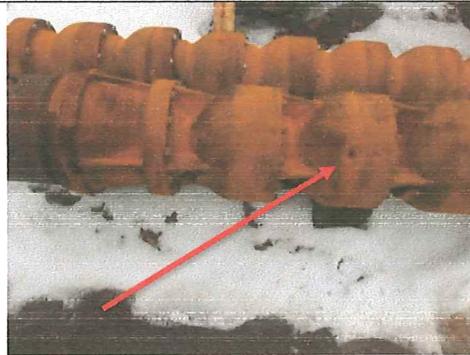
Hole through casting

There is a hole through one of the castings. The casting discharge surfaces are heavily eroded and pitted. The casting interiors have moderate to severe erosion.

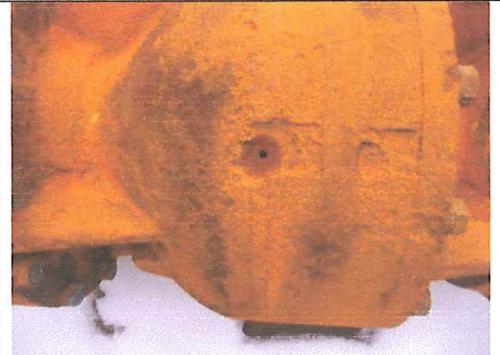
Hole in casting

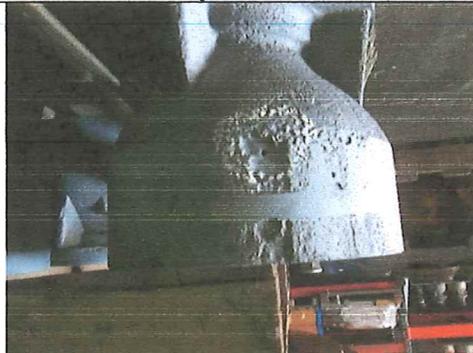
Heavy exterior corrosion and hole in casting after disassembly and clean

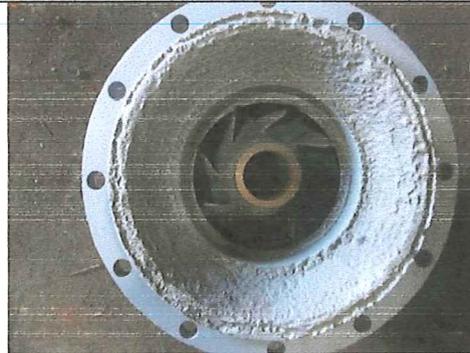
Heavy corrosion erosion to casting volute (typ.)

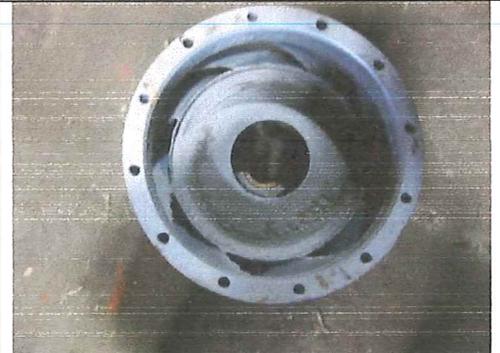
Moderate erosion to casting interior (typ.)

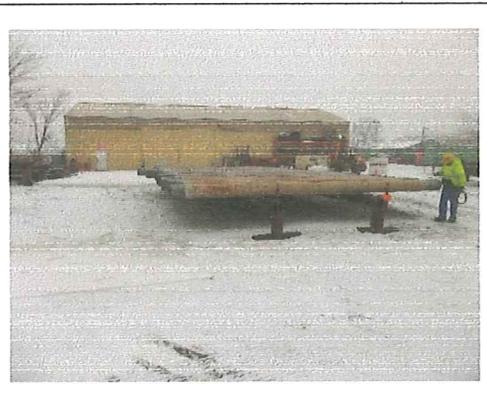
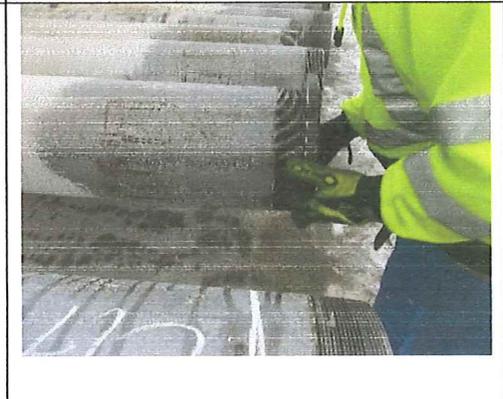
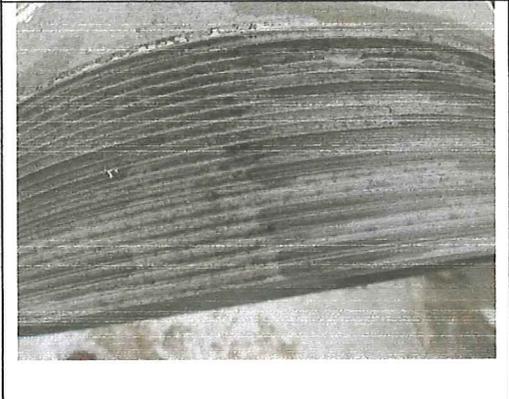
<p>877' (tally) of 10" Line Pipe string racked in Layne sandblast area.</p>	<p>Male threads and coupling threads were inspected with API calibrated ring gauges.</p>	<p>Flattened threads.</p>

The Well 10, 10" Line Pipe string consists of forty-two lengths that tally 877'. One joint is a half random at twelve feet long while the remaining forty-one are single random lengths. Eleven of the joints are threaded 8RND, one joint is a transition from 8RND to 8V thread, and the remaining joints are 8V thread. Eleven 8V male threads and eight 8RND male threads are in poor condition. Twelve 8V male threads, including the transition length, and five 8 require thread chasing. Three 8V couplings and seven 8RND couplings have eroded and/or damaged threads.

Cut and thread eleven 8V male threads and eight 8RND male threads. Replace three 8V couplings, seven 8RND couplings, and both surge control valves. Plan a contingency to cut and thread up to five 8V and seven 8RND threads pending their condition after removing the couplings to be replaced. Repair twelve 8V male threads and one 8RND coupling thread with machine chasing or file. Plan to replace pipe lost to cut and thread with approximately twenty-one feet of new 8" T&C Line Pipe, 8V thread. Epoxy coat all pipe for reinstallation.

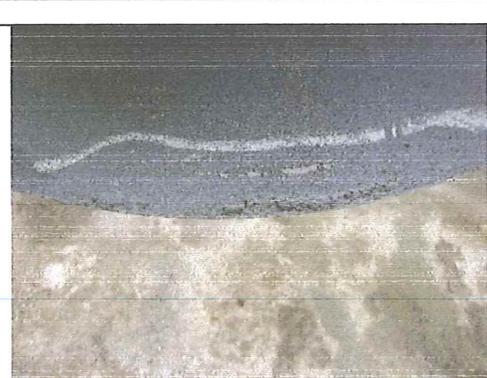
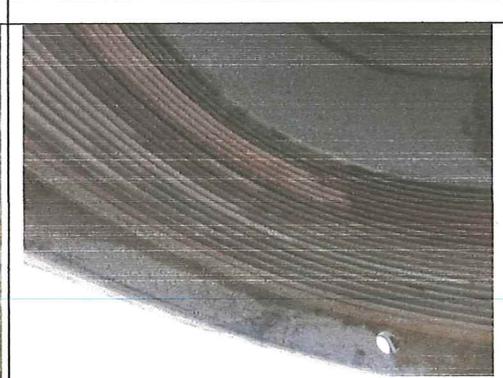
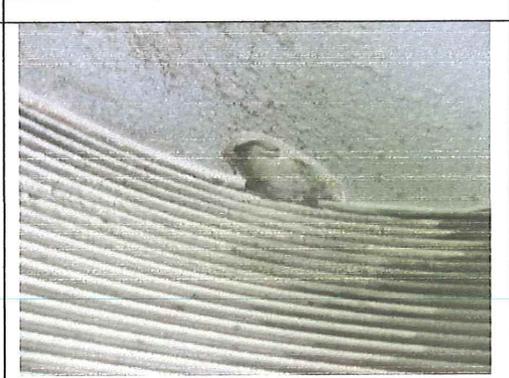
<p>Pitting at male end face.</p>	<p>Eroded coupling thread</p>	<p>Pit in pipe face within coupling.</p>

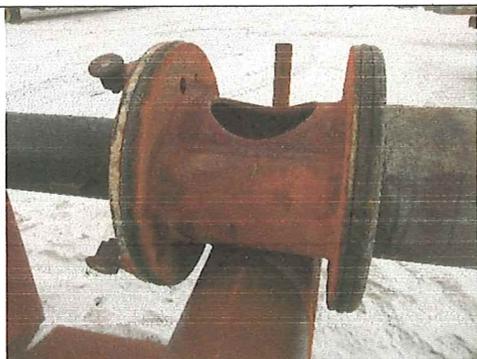
Internals of the Baker pitless adapter in good condition.

The Baker pitless internal components are in good condition. The 10" x 44" welded pitless nipple has 8 RND threads and is in good condition.

Replace pitless O-Rings and reinstall.
